IRIS-4 / EDGE
Firmware 4.20.1

This document details changes from firmware Version 4.19.12 to Version 4.20.1 for the IRIS-4 & Edge VS/DS terminal families.

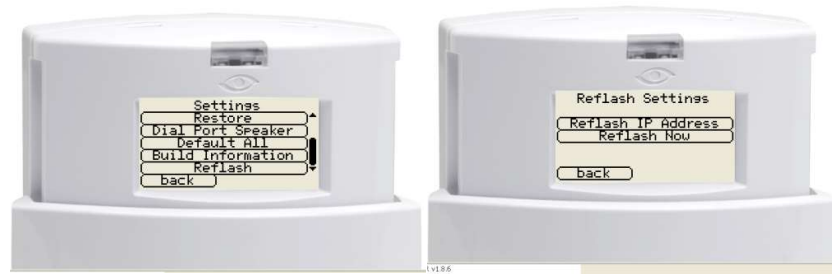
Alternatively, for local upgrade, connection to the reflash server can be instigated from the installer menu, Settings->Reflash:

The reflash IP address is set by default to AddSecure's reflash server (195.59.117.164) and does not need to be changed unless another reflash server is to be used.

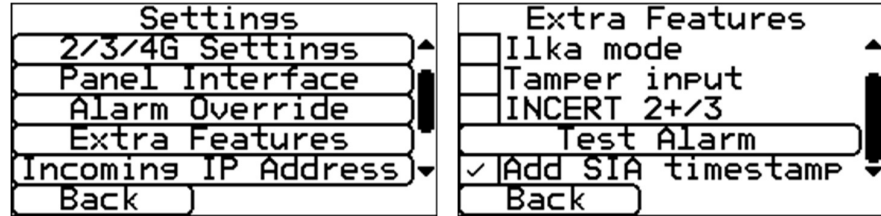
An option to add a timestamp to all internally generated SIA format messages (including pin input alarms) has been added to provide monitoring centres with information on when the alarm was generated.

This option is selected from the Extra Features menu on the touch or virtual touch screen.

Alternatively, it can be enabled by AT command `AT%G205=1` (0 to disable).

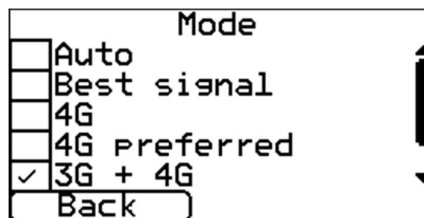
A new cellular mode (3G and 4G only) has been added for installations using SIP Voice over IP to ensure that 2G, which does not have sufficient bandwidth for VoIP audio, is never used.

This setting is now the default for terminal variants EDGE VS5010, VS5051 and VS5053. These terminal types which have earlier versions of firmware will be automatically updated to this setting when reflashing to V4.15.0 or later.

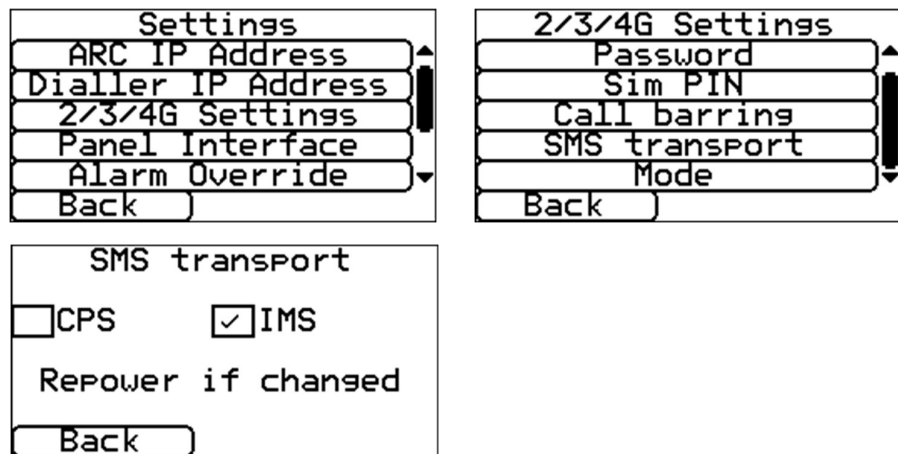
5.16.3 Added SMS Transport selection

A mode can now be set (CPS) for use with SIM cards that support 4G but do not support sending SMS messages over 4G. This is set through the Touch menus:

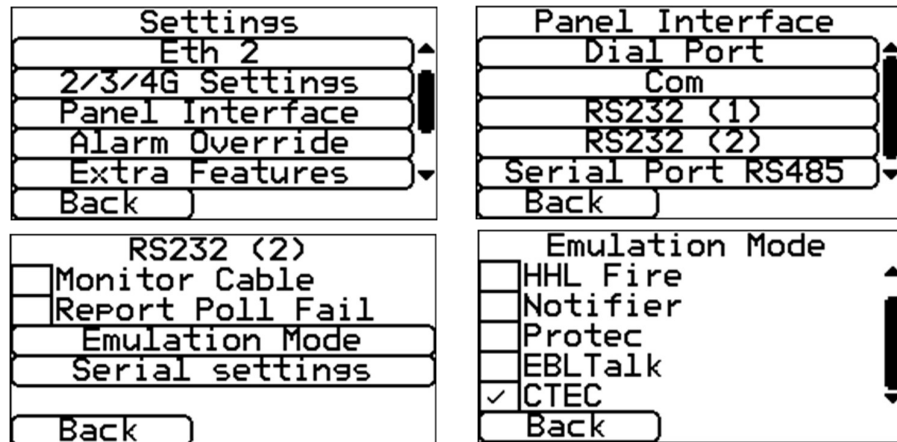
The C-TEC interface is available on the second RS232 port on the IRIS Touch terminal. It can be enabled via the menu **Settings > Panel Interface > RS232 (2) > Emulation Mode**. Scroll down and tick the **CTEC** option.

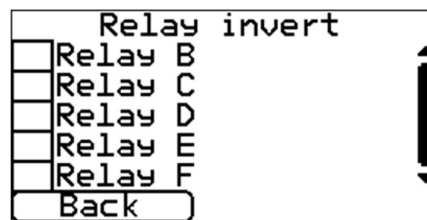
5.2.1.8 Revised Touch Screen Layout

The Touch screen and virtual Touch screen layout has been changed and tick boxes that were previously on the right hand side have been moved to the left hand side, as shown below. This has allowed more space to be allocated to the scroll bar (where displayed) to make it easier to use.

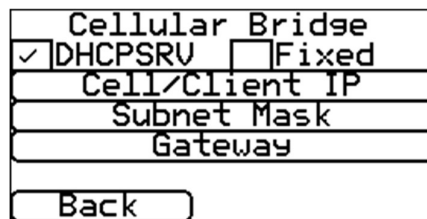
5.21.10 Changes to Cellular Bridging Mode

The Cellular to Eth2 option has been revised and improved. There are now two options - Cellular Bridge and Cellular Routed. Cellular Bridge maps the device connected to the Eth 2 socket to same IP address as the SIM card. Cellular Routed offers mapping to a configurable device IP address and Eth2 IP address. There is a DHCP server with the terminal that can be enabled in both modes that means that the connected device does not have to be manually configured with an IP address if it supports DHCP.

By default the Cellular Routed mode is selected, with Forwarded IP (i.e. the address of the attached device) set to 192.168.1.1 and the Gateway IP (i.e. the address of the Eth2 connection on the terminal) set to 192.168.1.254. The DHCP server is on by default.

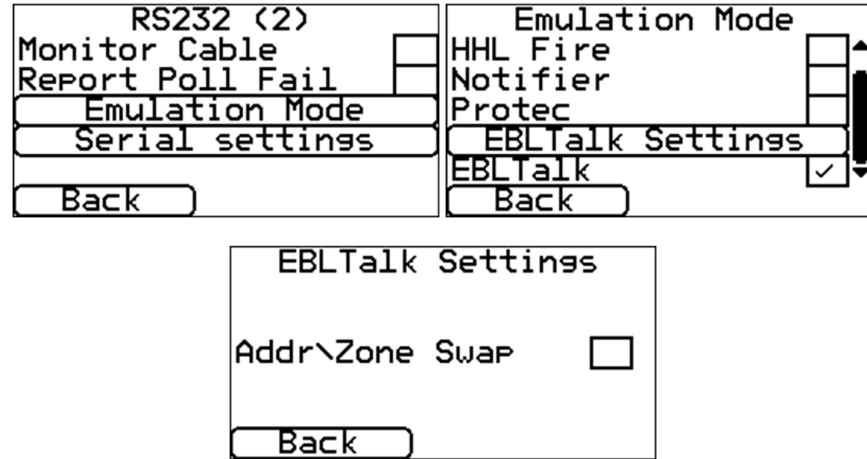
5.27.3 EBLTalk Fire Panel Support

Support for Fire Panel serial interfaces has been extended to include Panasonic EBLTalk fire panels on the second RS232 port. This allows technical information from the panel serial port to be reported to the monitoring centre alongside the normal Fire and Fault reports.

A special option required by some monitoring centres to swap the message Zone number and address is also provided as shown above. For more information please contact AddSecure Technical Support.

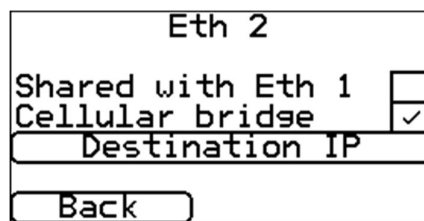
5.28.2 Ethernet to Cellular Bridge

IRIS terminals with cellular connection and two Ethernet ports (IRIS-4 440, IRIS-4 640D) offer the possibility of bridging between the cellular connection and the second Ethernet port (Eth 2). In this case a DHCP server is also provided on the Eth 2 port. This mode of operation is enabled when a SIM card is fitted to the terminal and has attached to the SIM provider's cellular data network and when the Ethernet 2 port is set to 'Cellular bridge' mode, as shown below.

Note - only a single Ethernet device is supported.

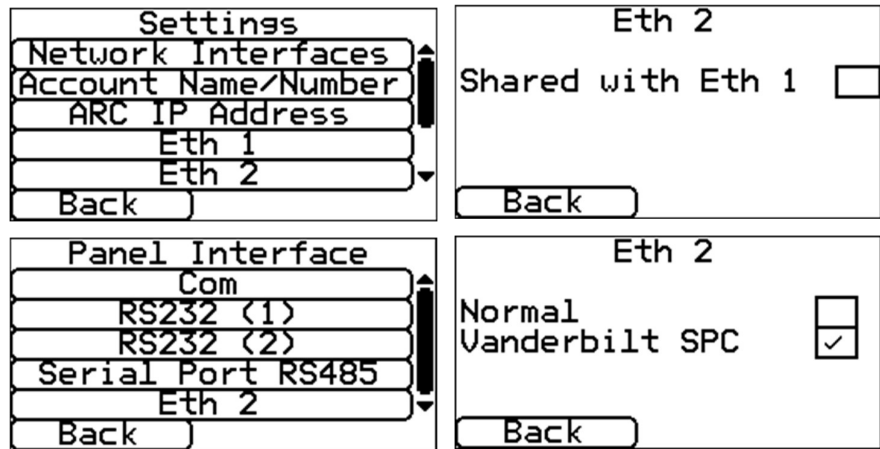
- 4) The IP Address and Remote Access settings have been removed from the terminal's touch screen menu as they are no longer required. When selecting Siemens mode, the option 'Shared with Eth 1' is automatically deselected.

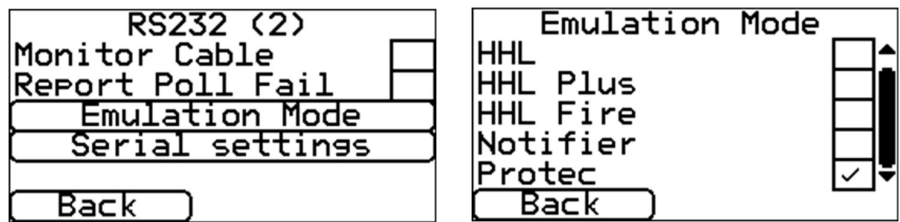
5.32.1 Protec Fire Panel Support

Support for Fire Panel serial interfaces has been extended to include Protec panels on serial port 2.

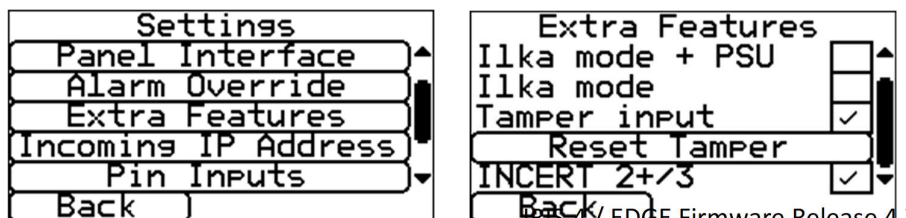
5.32.2 Tamper Restore

If a tamper switch activation occurs (including activation of the tamper input on non-cased variants), it does not restore automatically, it must be restored via the Touch Screen->Extra Features menu 'Reset Tamper' button.

If the tamper physical condition has been restored before 'Reset Tamper' has been selected, the reset button will be removed and the tamper restore message will be sent to the monitoring centre. If not, the button will be removed and the tamper restore will be sent when the condition is restored.

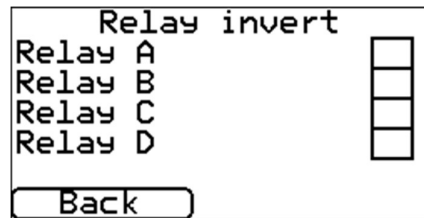
5.32.5 Relay Invert Setting

A relay invert setting is available in the 'Relays' menu.

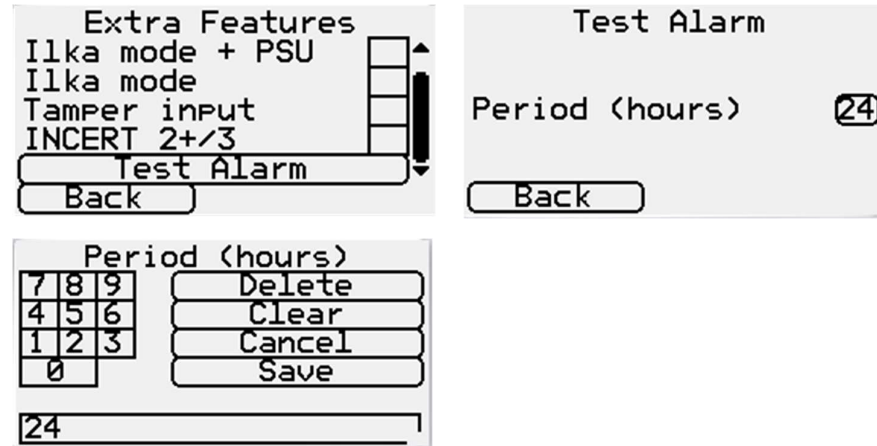
In cases where the IRIS terminal is not connected to an alarm panel that can itself generate a regular test alarm (e.g. when inputs are used), it can be convenient for the terminal to generate a regular test alarm. This gives the monitoring centre a consistent way to monitor end-end connectivity across many installations.

Previously IRIS-4 4xx terminals have supported test alarms over PSTN only, but not over all paths (i.e. the first path available).

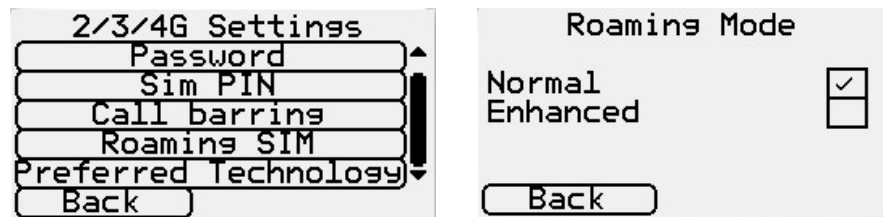
This was removed from this menu on the IRIS-4 series because the meaning of the selection was ambiguous. The intention of the setting is 'enhanced' roaming where the terminal monitors the signal strength of the signal from all available cellular service providers and selects the one with the highest signal strength. It was identified that the setting was being selected by some installers if the SIM card in use is a roaming enabled SIM card and where there was no need for the selection of the operator with the strongest signal, as described above. This could result in intermittent trouble being reported by the terminal to the monitoring centre. The selection of this feature, for those who need it, has therefore been moved to the settings menus.

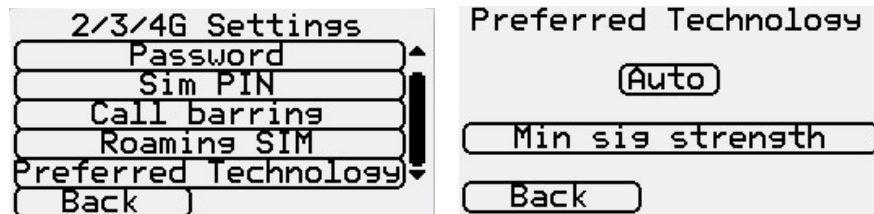
5.35.2 Selection of Preferred Technology

This setting allows the installer to select the preferred technology (Auto, 2G, 3G or 4G) used by the dialler for its cellular connection and the minimum signal strength required for the connection. If the signal strength is not at the required level (default is 10), the terminal will use a different technology that does meet the requirements. A setting of 'Auto', which is the default, instructs the terminal to select the technology with the highest signal strength, as with IRIS Touch NG terminals.
